New York State Department of Transportation

Yellow Flag NB22CTW025

BIN: 1065318

Feature Carried: 278I278IX2M23027

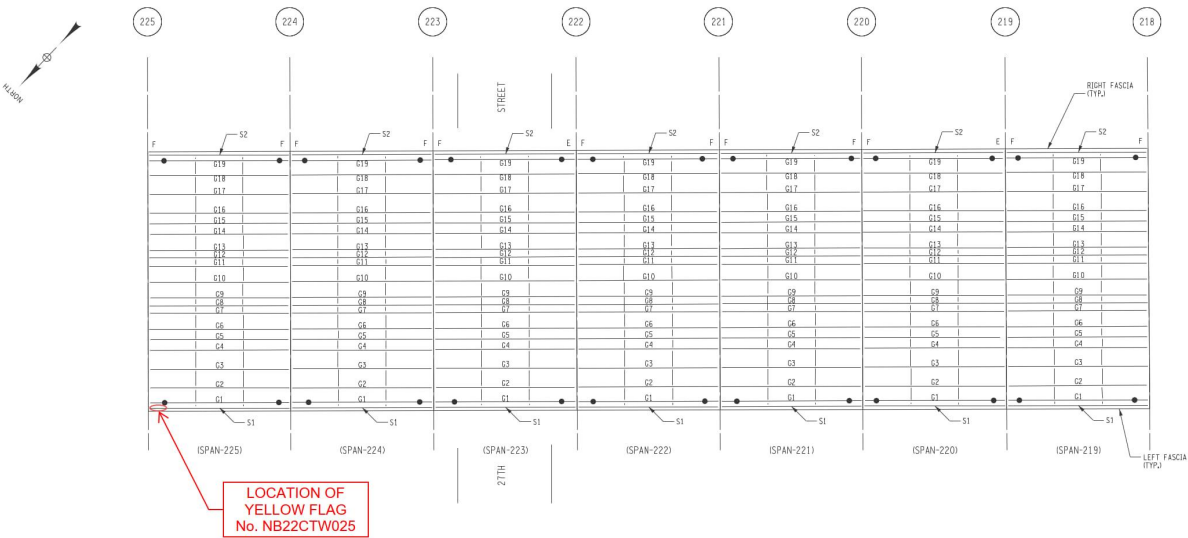
Photo Number: 1

Attachment Description: Framing Plan - Span 225

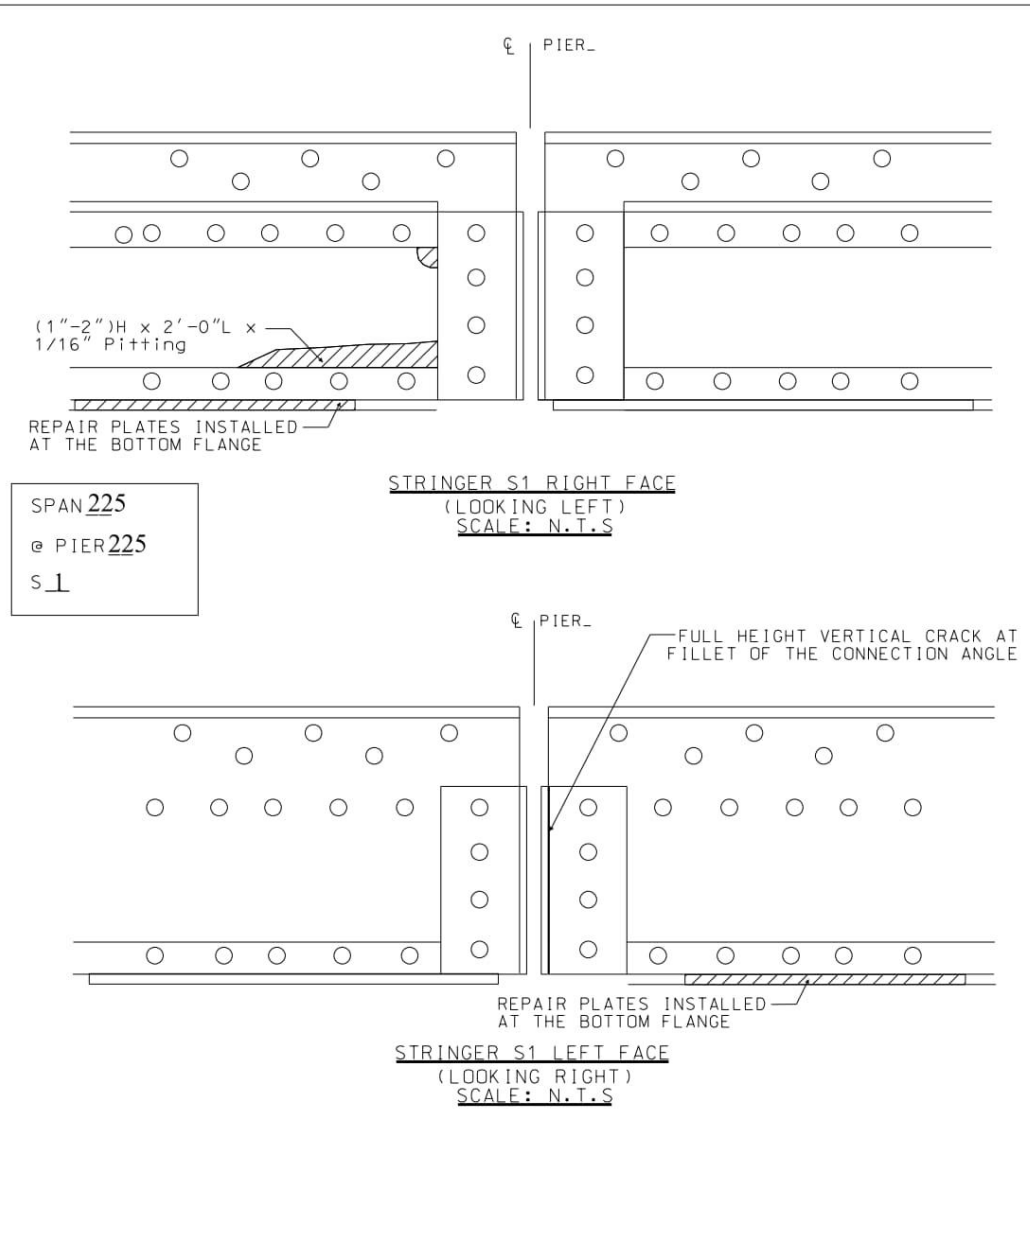
Photo Number: 2

Description: The left side connection angle at Stringer S1 in Span 225 at Pier 225 exhibits a full height thru vertical crack in the fillet of the connection angle. The right side connection angle exhibits no significant defects.

Attachment Description: Yellow Flag Condition Sketch

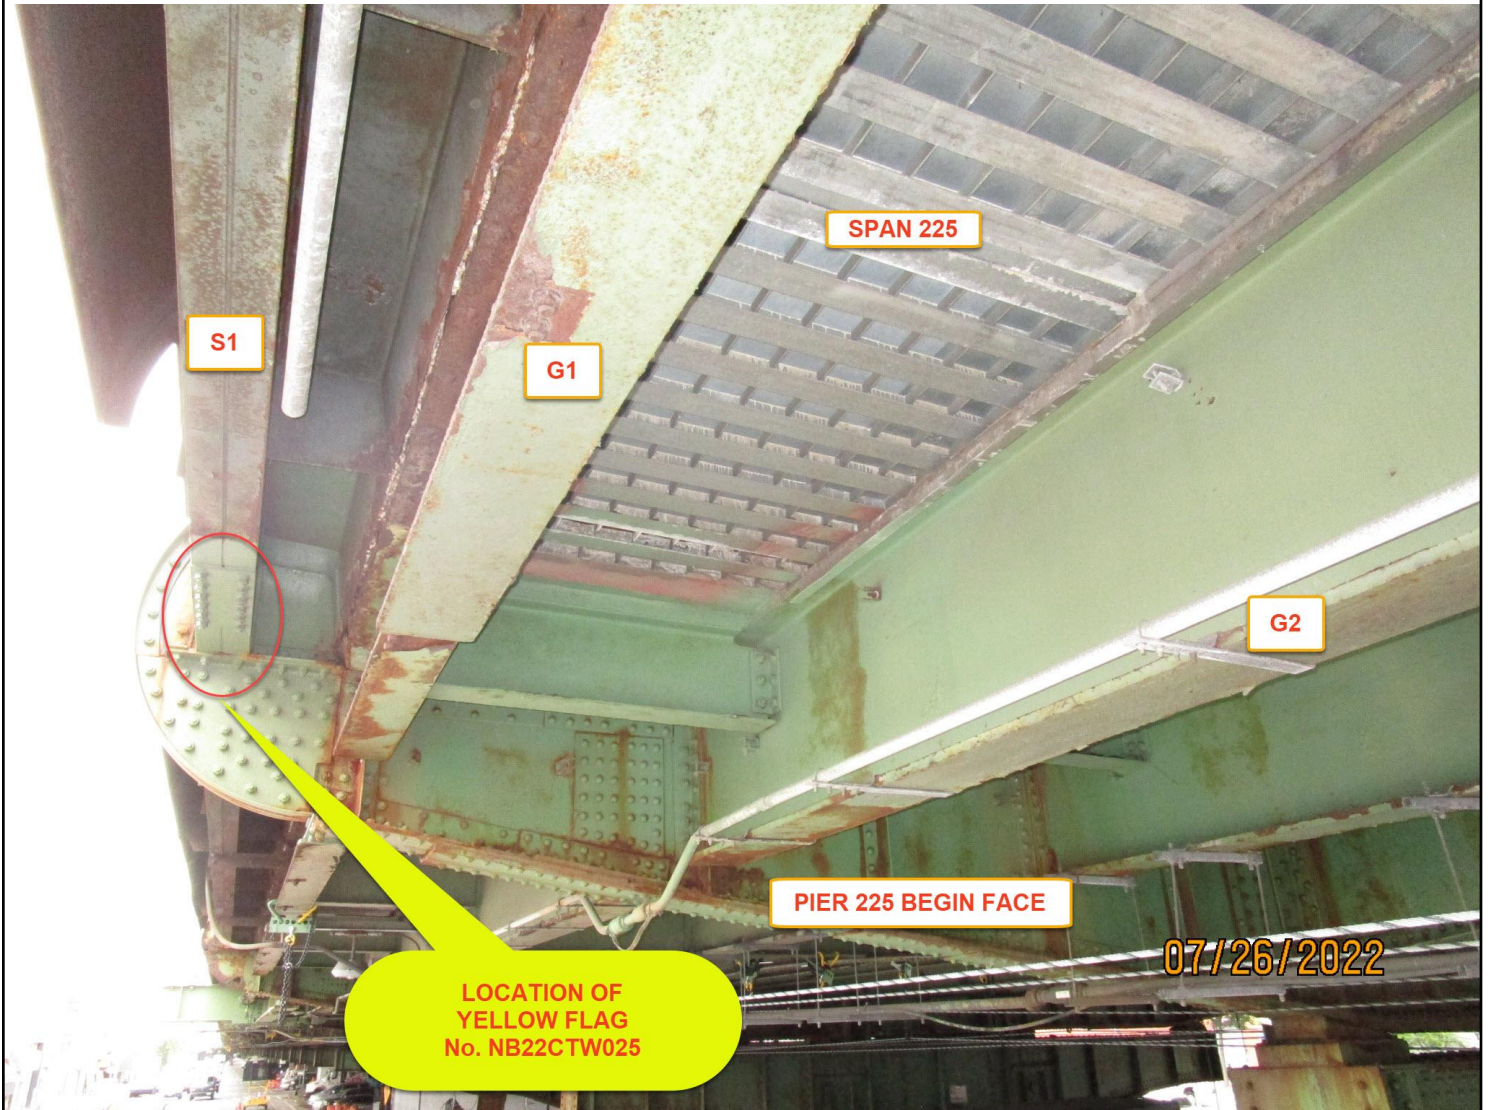
Photo Number: 3

Attachment Description: General view of the flagged condition at Span 225 Stringer S1 at Pier 225. Looking End.

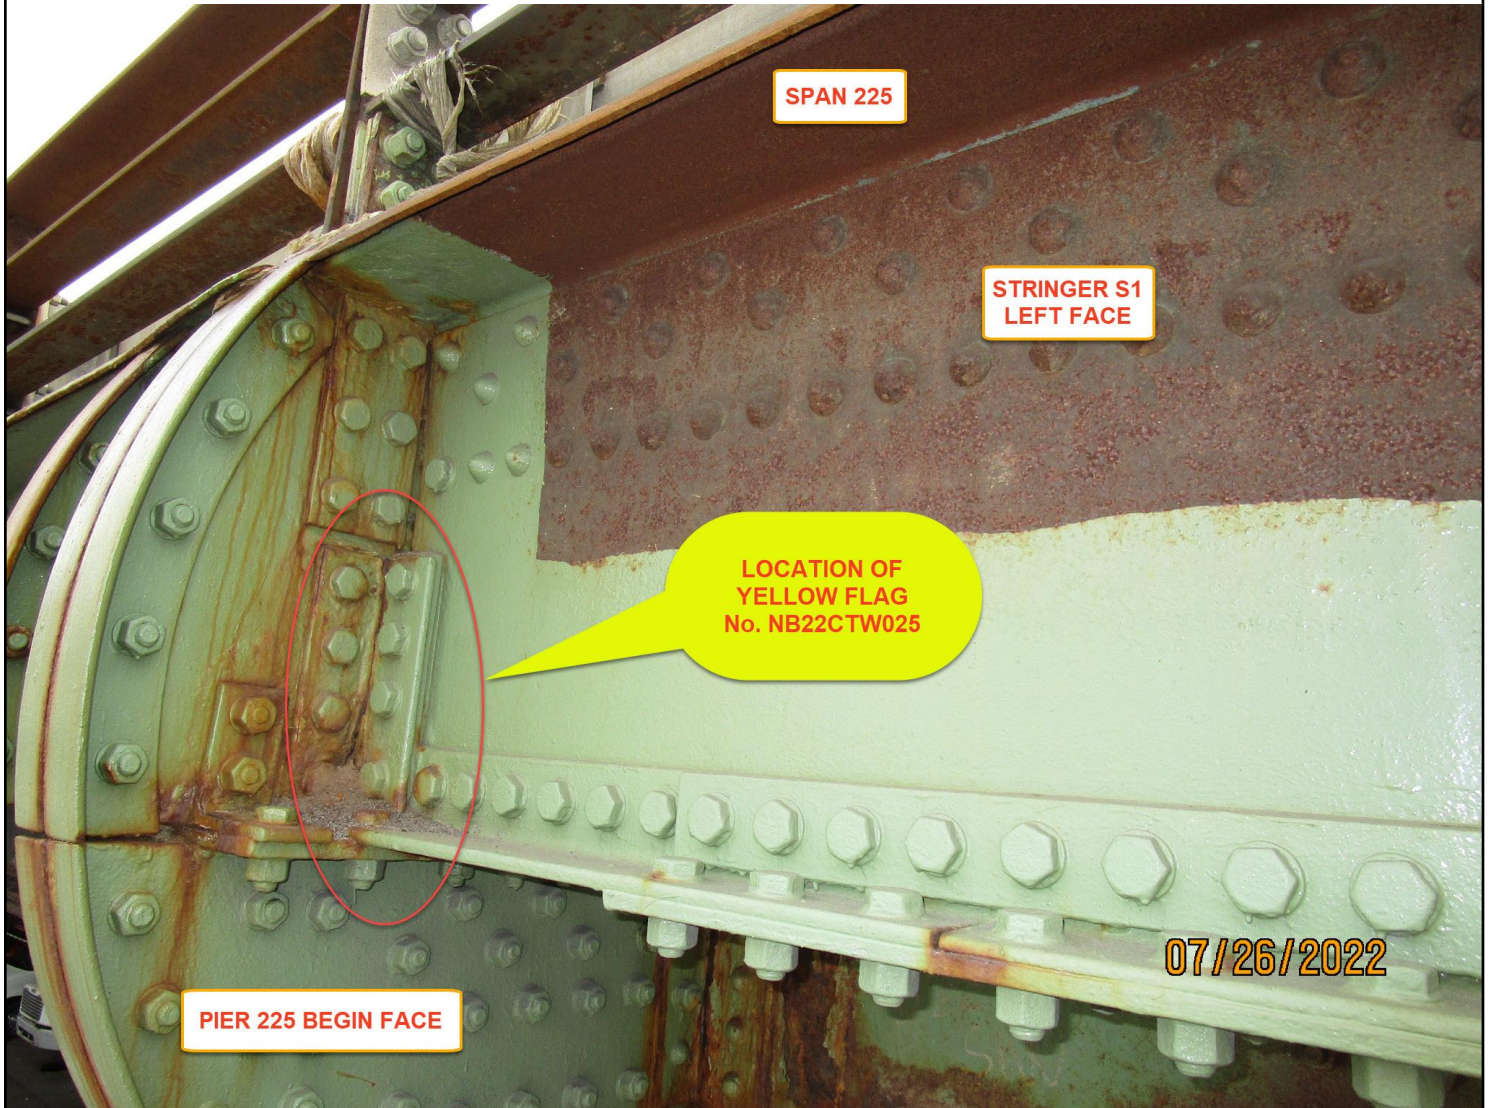
Photo Number: 4

Attachment Description: Close up general view of the flagged condition at Span 225 Stringer S1 at Pier 225. Looking End.

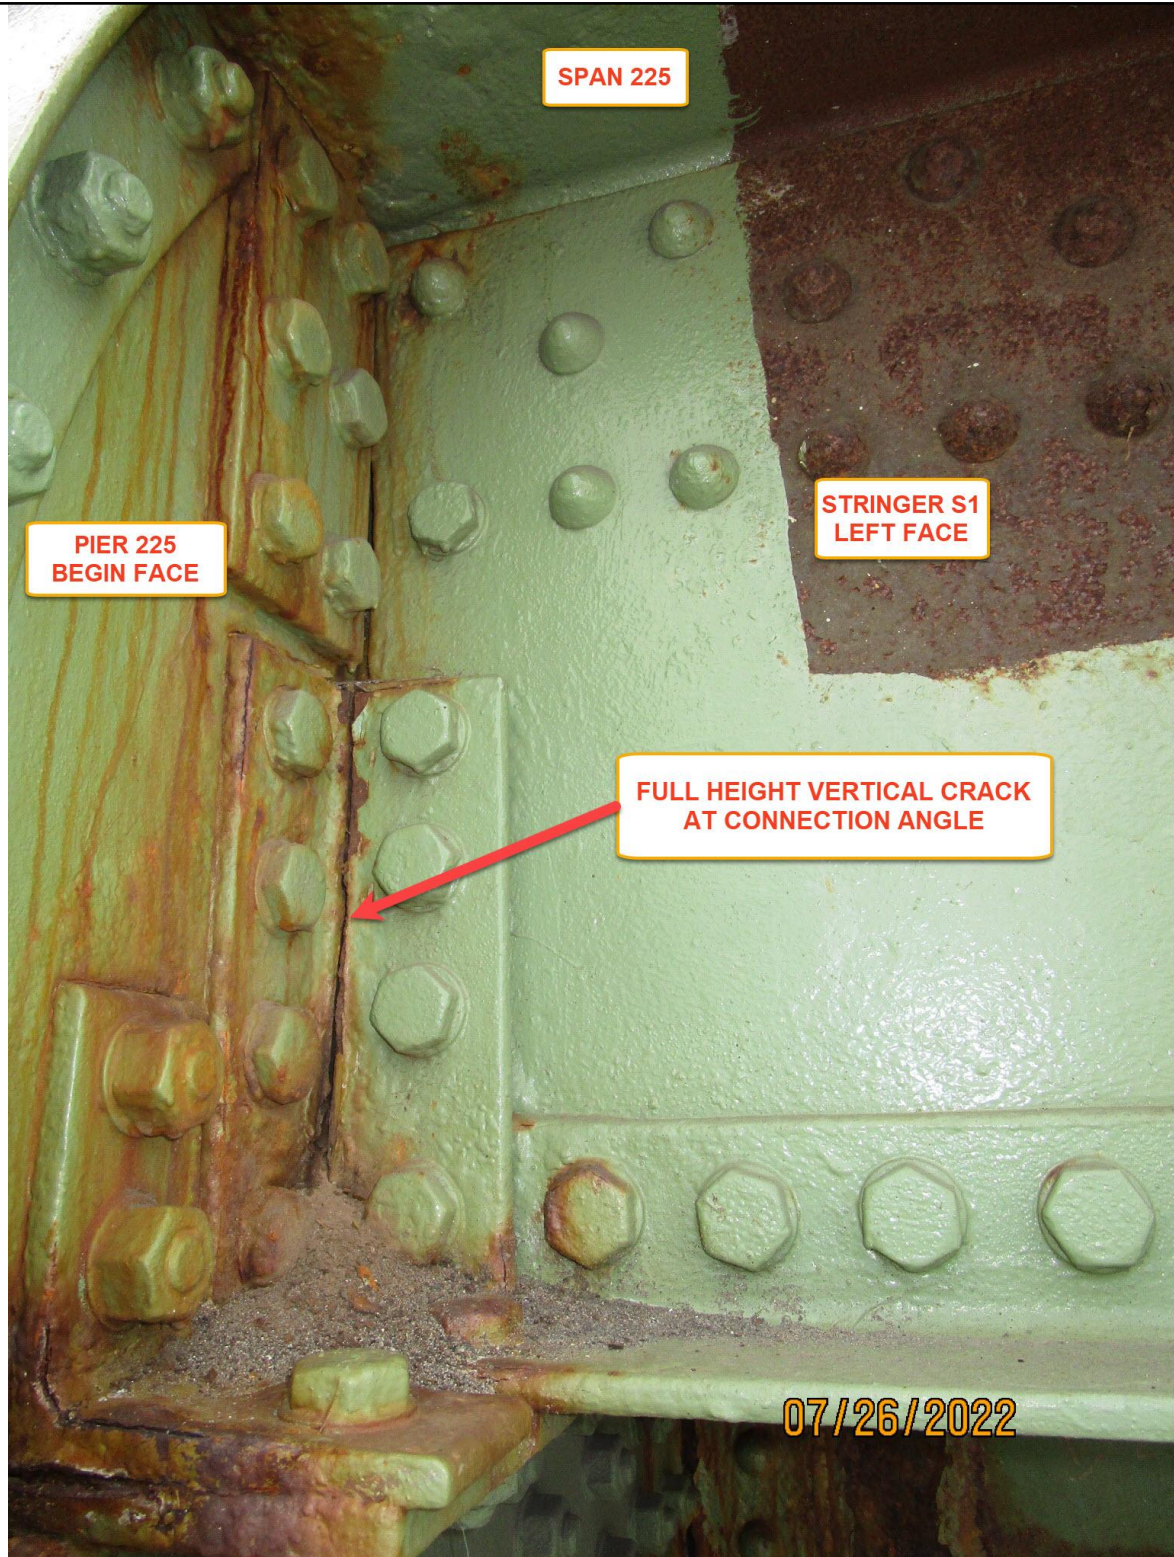
Photo Number: 5

Attachment Description: The right side of Stringer S1 exhibits a full height crack at the connection angle. Looking End Right.

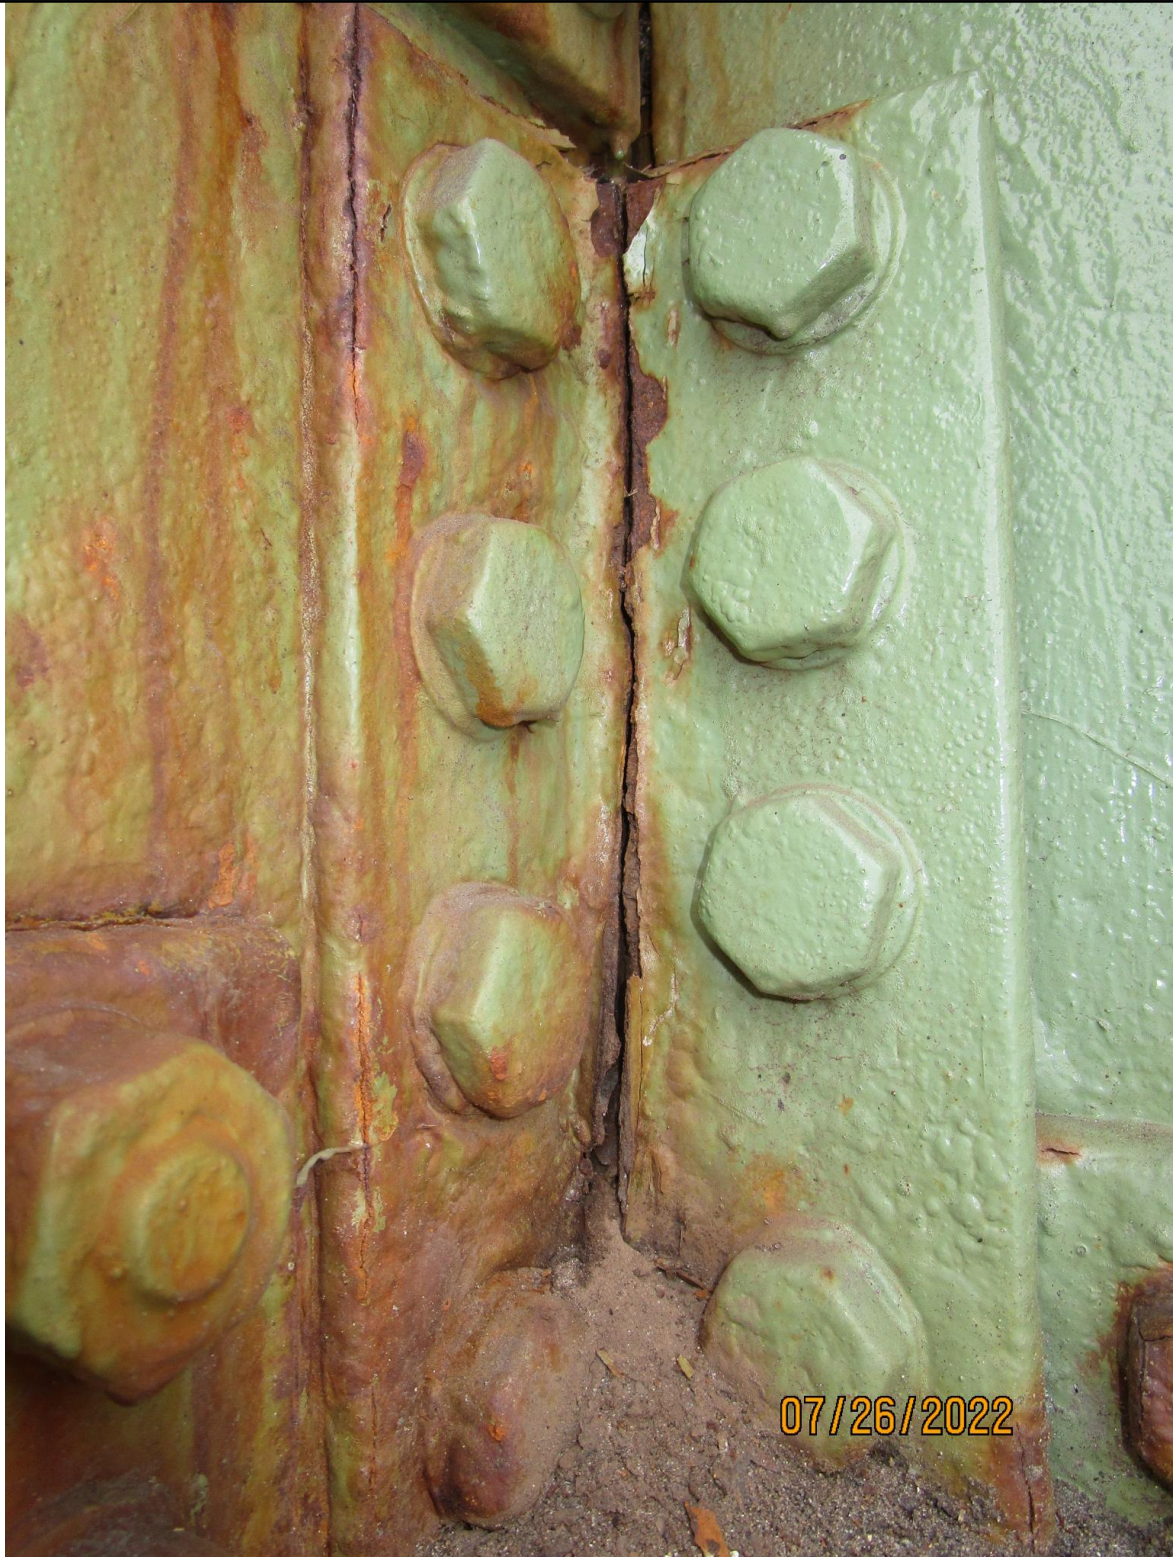
Photo Number: 6

Attachment Description: Close up view of the full height crack at the left side connection angle. Looking End Right.
